LBYC / RPNYC Wellington Harbour Club Mooring Inspection Report 2023

Prepared by Wilson Underwater Services Ltd

Inspection Date: 29/30 April 2023

Joint Owners: Lowry Bay Yacht Club (LBYC) and Royal Port Nicholson Yacht Club (RPNYC)

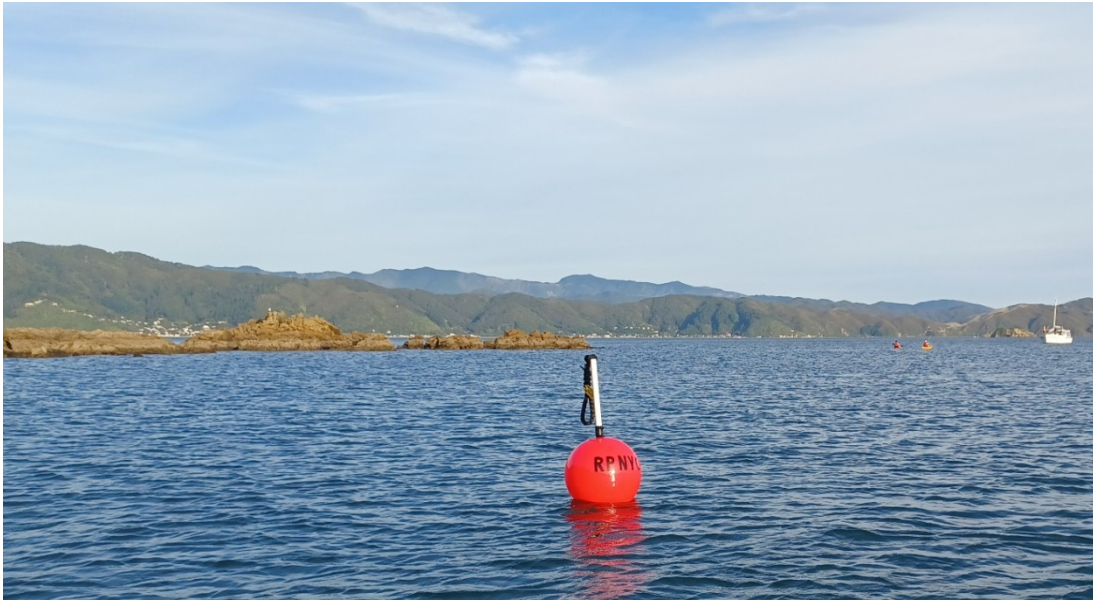
Somes – Matiu South (Polyform CC-4)

29.4. 15:00	act South Somes-Matiu	5.3	38	7	Polyform Float CC-4	28mm partly new	0.6 plus 3 kg	7	existing	existing	124 mm	124 mm	60 mm+	Inspection after maintenance: passed Rope chafed below Ferigi Buoy to 2 strands rope and float replaced Spring chain min diameter 14 mm, replace by 12/23!

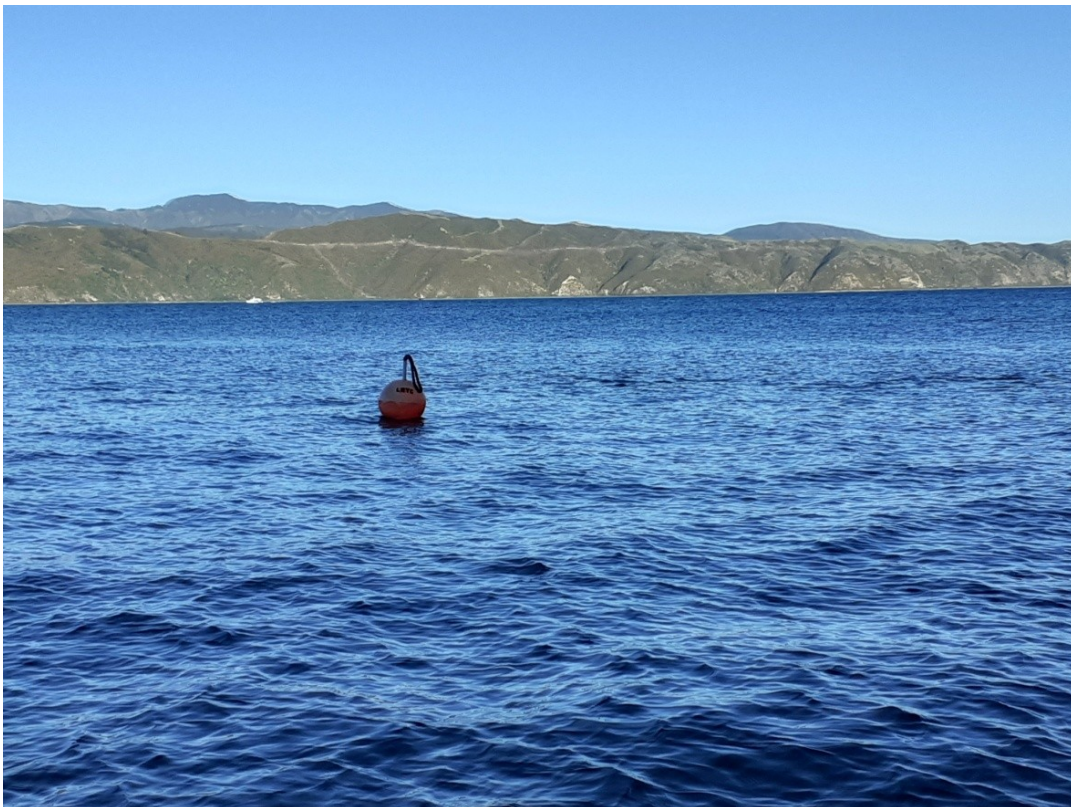
30.4. 10:59	act Scorching Bay	3.2	20	8	Polyform Float CC-4	28mm	0.6	7	existing	existing	120 mm	120 mm	1	Inspection after maintenance: passed Float in good condition (refurbished 2021) Spring chain min diameter 19 mm

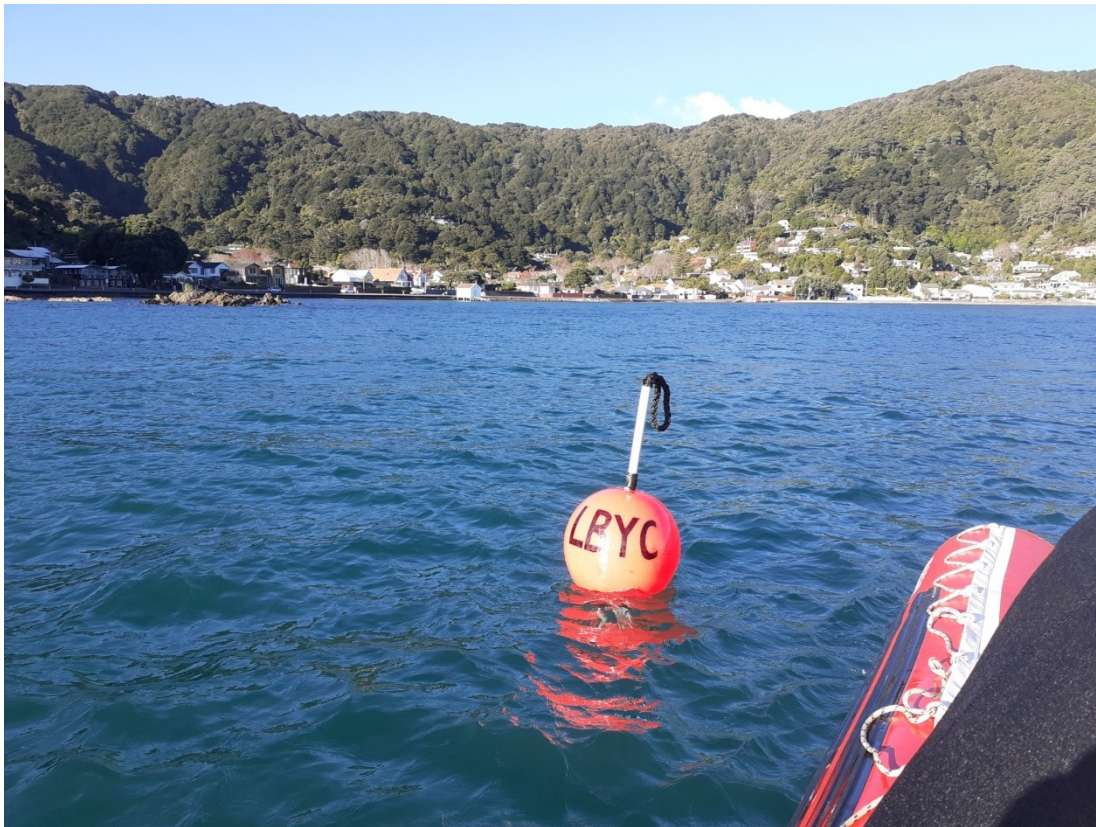
Lowry Bay / Sorento Bay Mooring

29.4. 17:15	act Lowry / Sorento Bay	3.2	20	4	Polyform Float CC-4	28 mm	0.6	7	existing	existing	120 mm	120 mm	1	Inspection after maintenance: passed incorrectly assembled after damage early 2021 pole slipped down Spring Chain min diameter 15 mm pole to be pushed up and secured by 12/23!

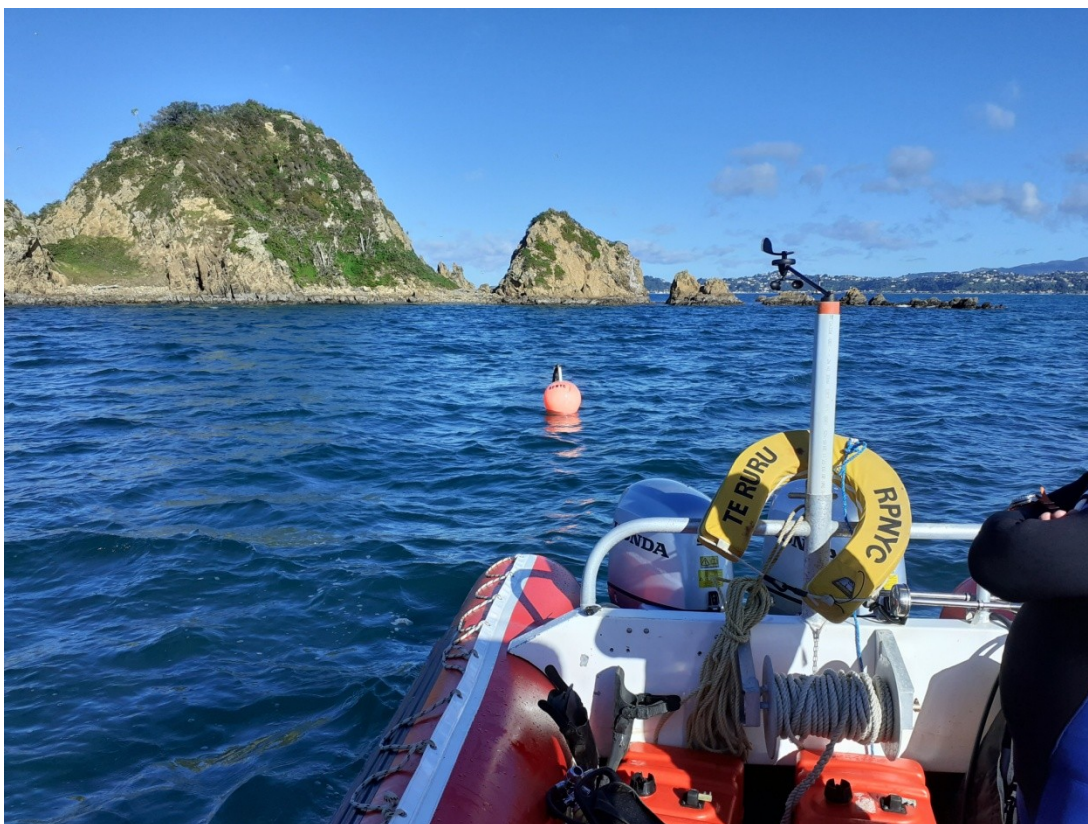
29.4. 14:13	act Ward Island	5.3	28	5	Polyform Float CC-4	32 mm	0.6	7	existing	existing	124 mm	124 mm	1	Inspection after maintenance: passed Spring chain min diameter 16 mm good until 2025

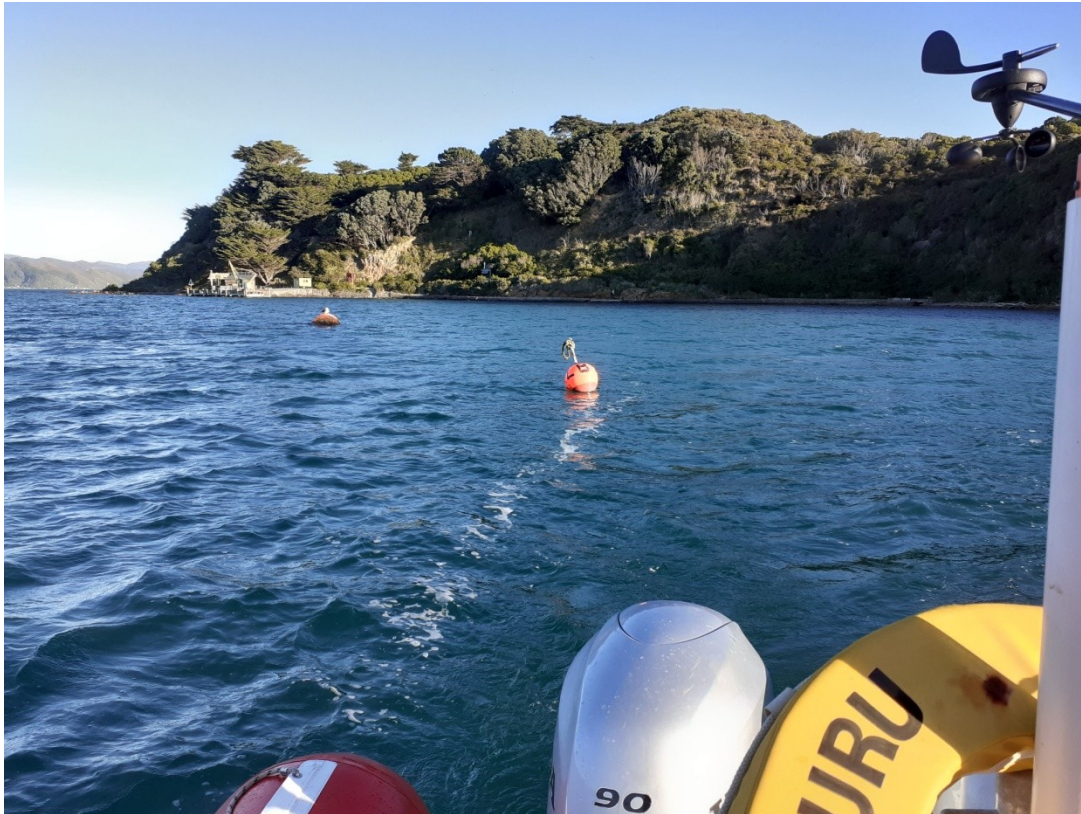
Somes - Matiu North (2021)

29.4. 16:30	act Noth Somes-Matiu	2	15	9	Polyform Float CC-4	32 mm	0.6	7	existing	existing	125 mm	125 mm	1 32 mm	Inspection after maintenance: passed Spring chain min diameter 23 mm Pole down, was pushed back and lightly secured

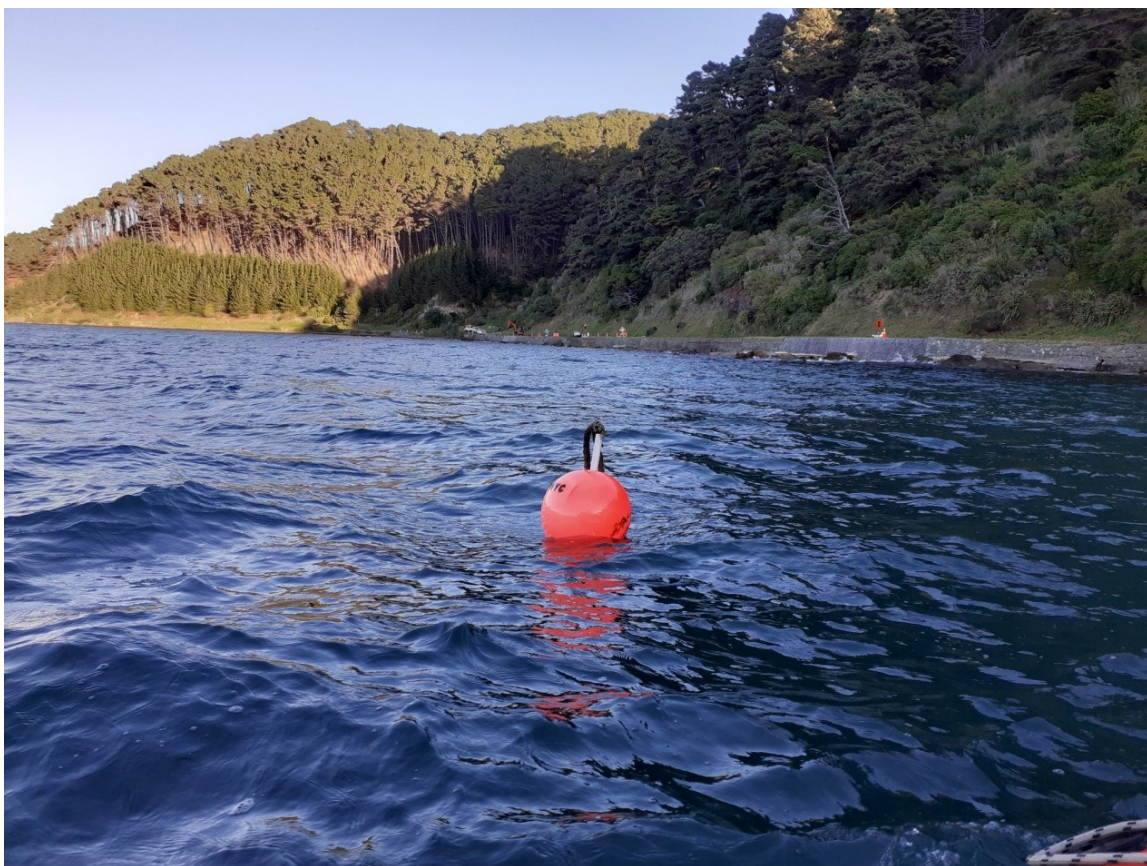
30.4. 11:20	act Kau Bay	5.3	38	6	Polyform Float CC-4	32 mm	0.6	7	existing	existing	120 mm	120 mm	1	Inspection after maintenance: passed all in good order Spring chain min diameter 19 mm

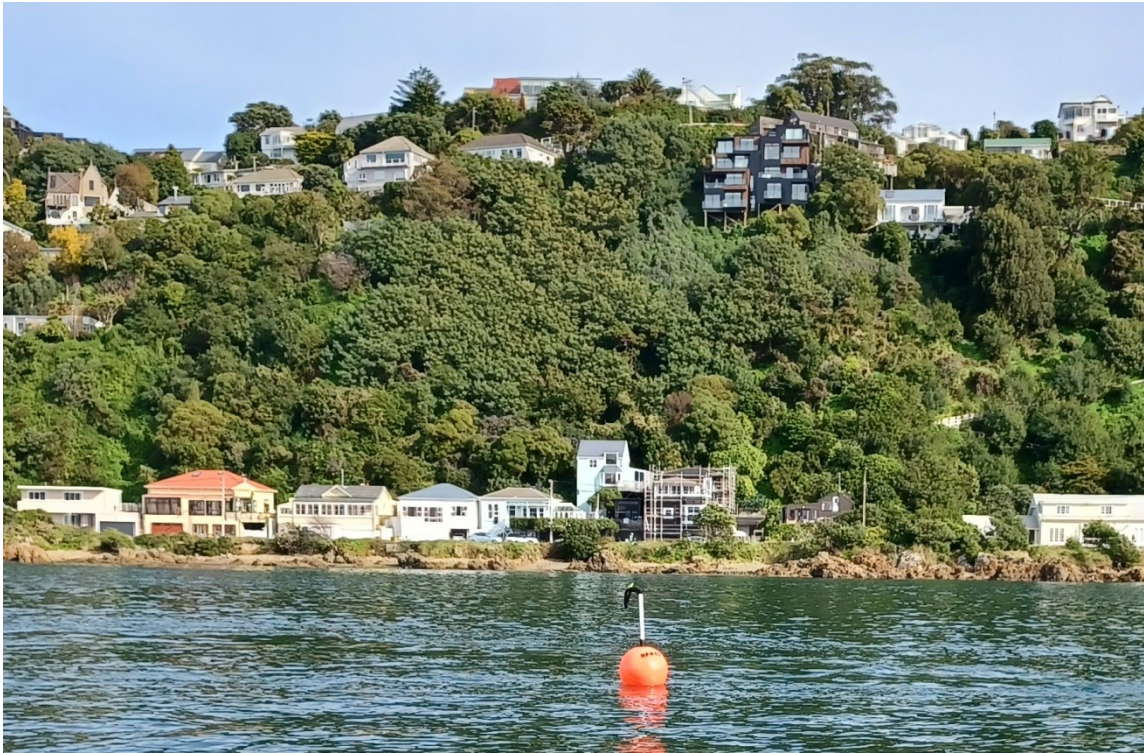
Seatoun / Worsler Bay

30.4. 9:20	act Seatoun/Worser	3.2	20	8	Polyform Float CC-4	28 mm new	0.6	7	new	new	122 mm	122 mm	1 new	Inspection after maintenance: passed float deflated, was replaced worn link bridged with shackle 24 mm
	act Spares retained held at RPNYC boat shed													
	Maintenance included:													Cleaning from marine growth, adjusting stand pipe adding weights: 7 kg of chain about 2 m below float
	Inspections included:													Method: measure smallest diameter of spring chain min diameter 15 mm
